STRUCTURE NO. 00708

PONUS RIDGE ROAD

ROUTE 15

(In depth)
Supplemental / Special Inspection
on
11/25/2011

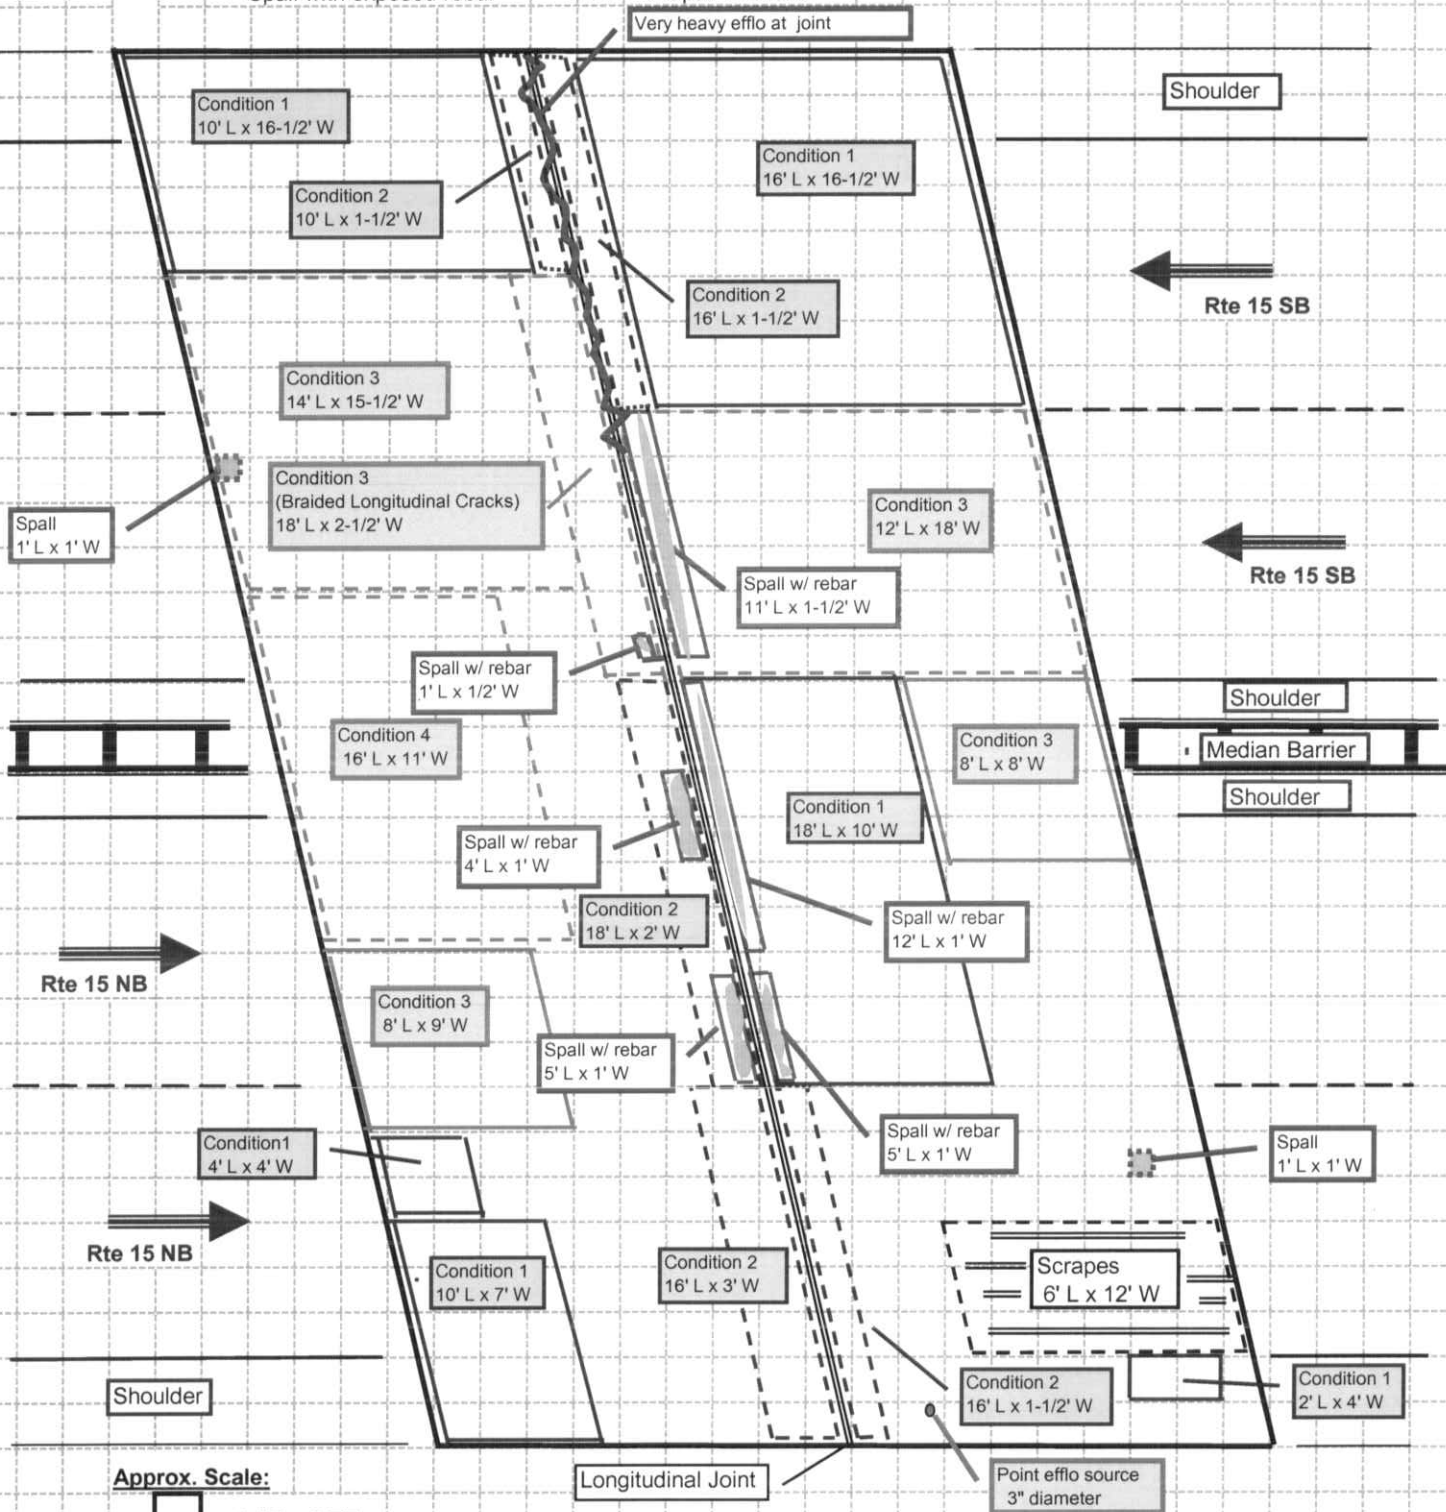
Total SF discoloration, stains, latent mapcracks = 824 SF

Percentage deterioration of overall deck area = 818.25 SF / 2627 SF = 31.1 %

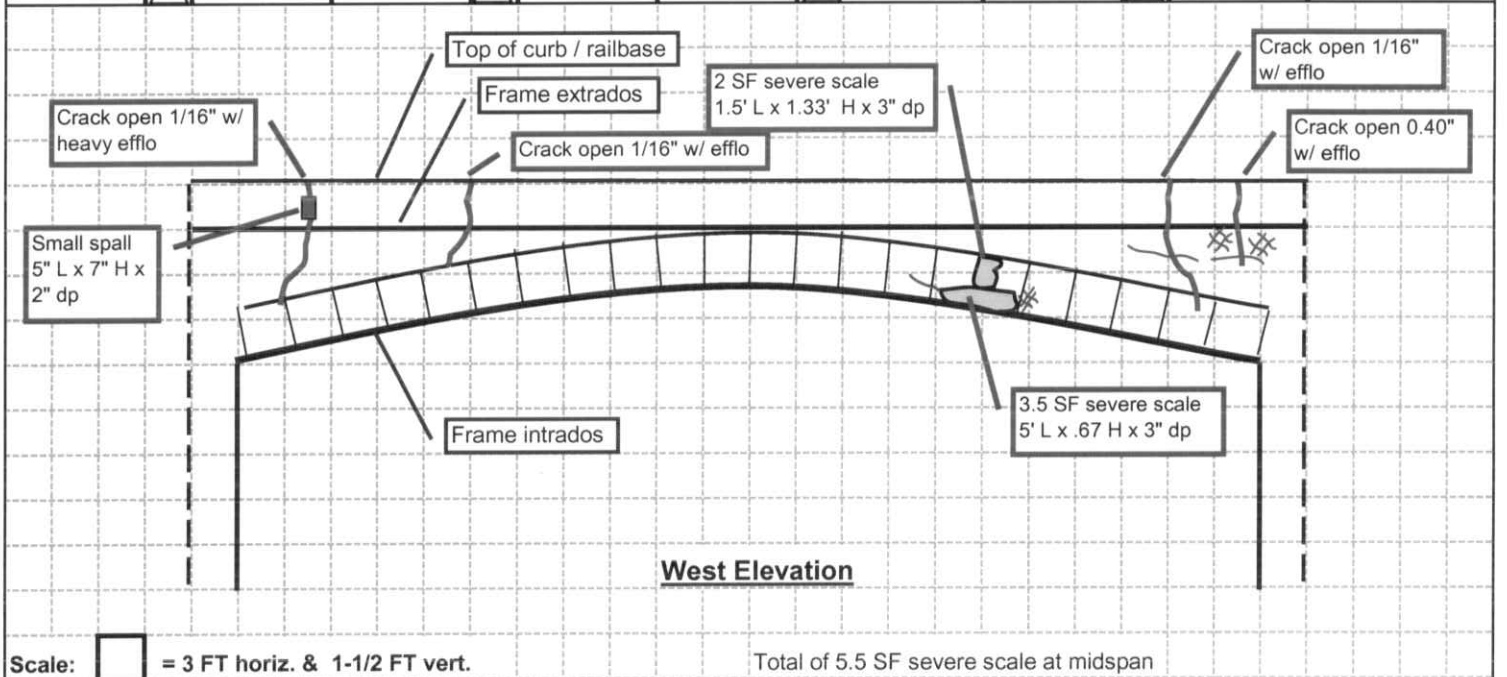
Frame fascias exhibit vertical / diagonal cracking with heavy efflorescence in the negative moment tension zones at all four corners (2 cracks @ NW, 2 @ SW, 2 @ SE and 1 @ NE). These cracks are structural in nature and extend into and across the curbs / railbases. See engineer's notes in "Additional Comments".

Note - Crack widths are measured at the top of the outside edge of the curb / railbase. See callout on Sheet 4, South abutment sketch.

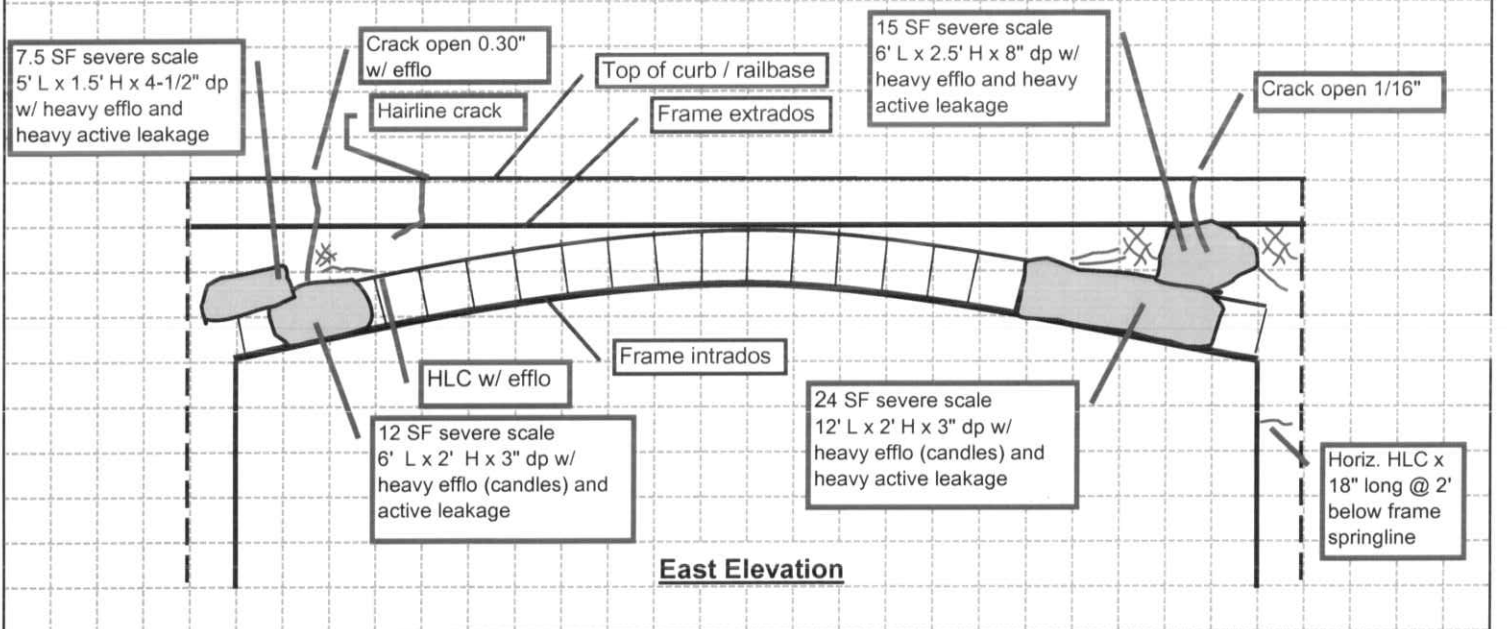
East fascia at the north end exhibits 39 SF of severe scale (overall dimensions 12 FT long x 4-1/2 FT high x 3 IN to 8 IN deep). The scale area shows heavy active leakage and heavy efflorescence with stalactite candles. Significant efflorescence is building up on the roadway below.

East fascia at the south end exhibits 19.5 SF of severe scale (overall dimensions 10-1/2 FT long x 3-1/2 FT high x 3 IN to 4-1/2 IN deep). The scale area shows active leakage and heavy efflorescence with stalactite candles. Some efflorescence is building up on the roadway below.

Total of 19.5 severe scale at SE corner.

Total of 39 SF severe scale at NE corner.

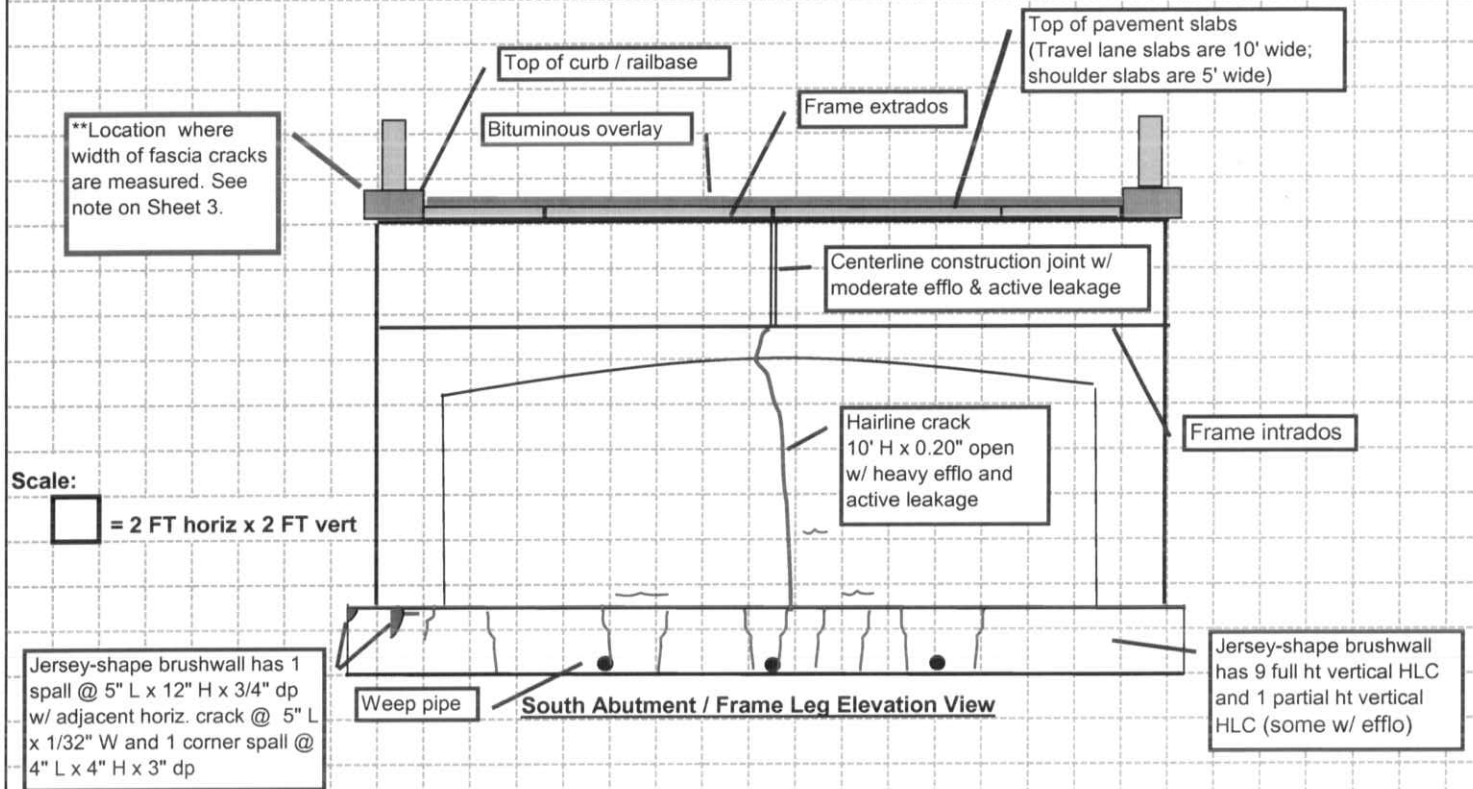
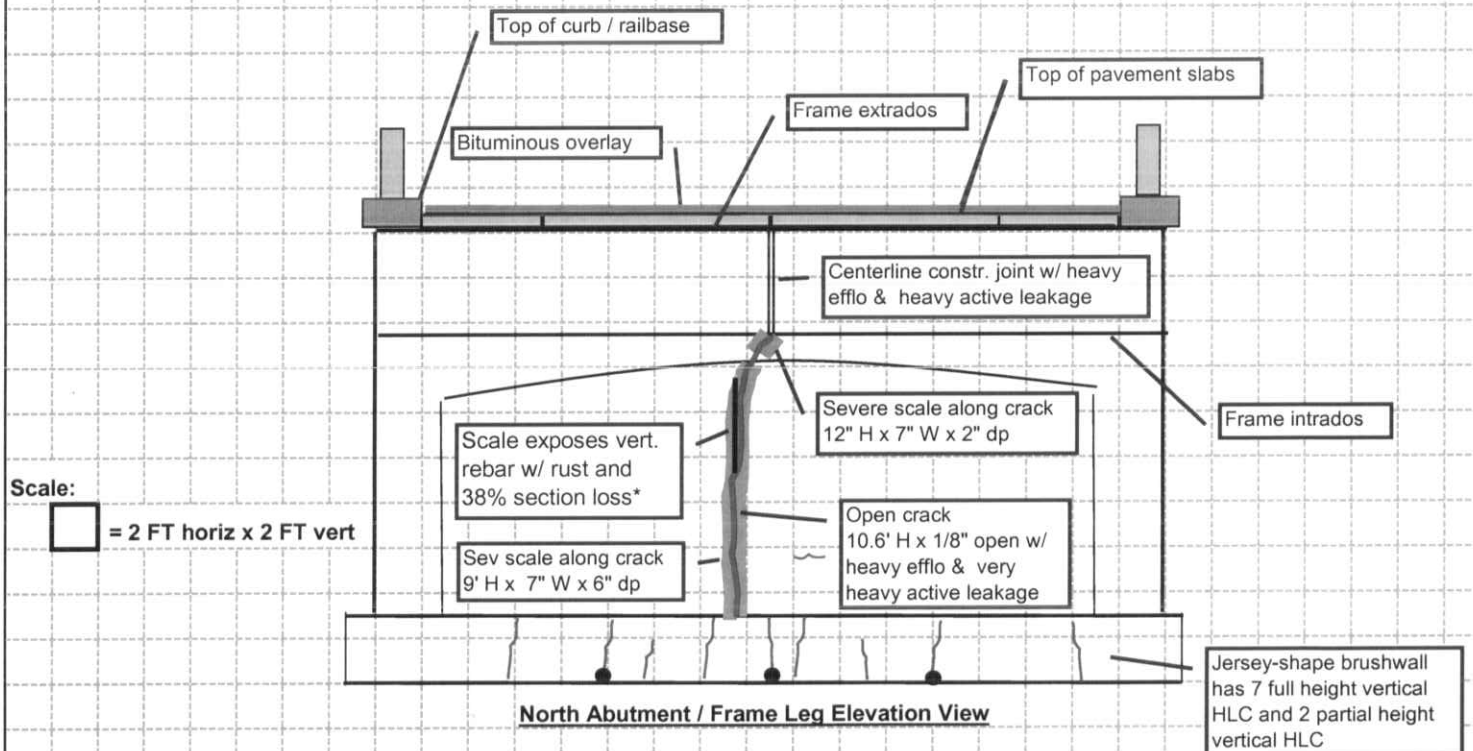
* Scale has exposed one vertical rebar approx 8' high, with heavy laminar rust and section loss.

Exposed rebar shows 11/16" dia. remaining of 7/8" dia. original (38% section loss)

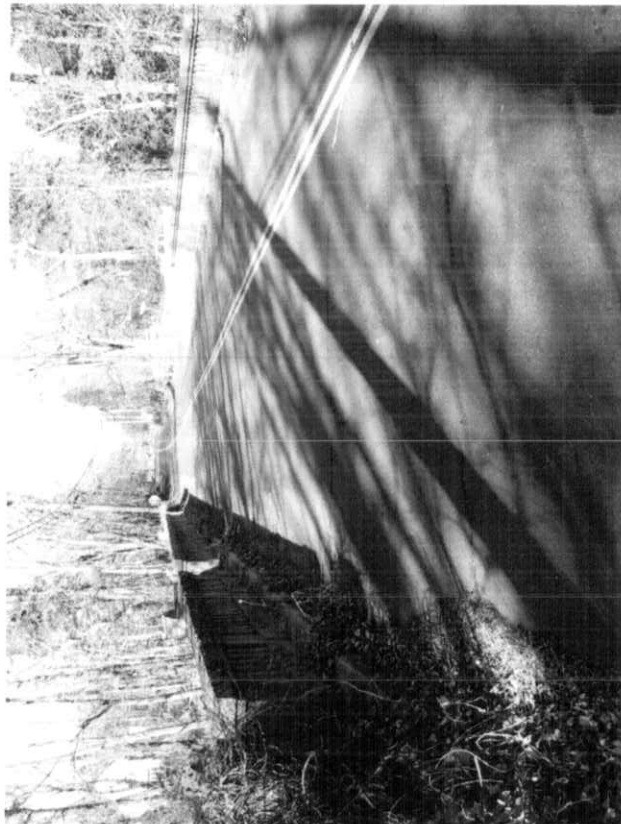
Description 1: Looking across bridge from south approach.

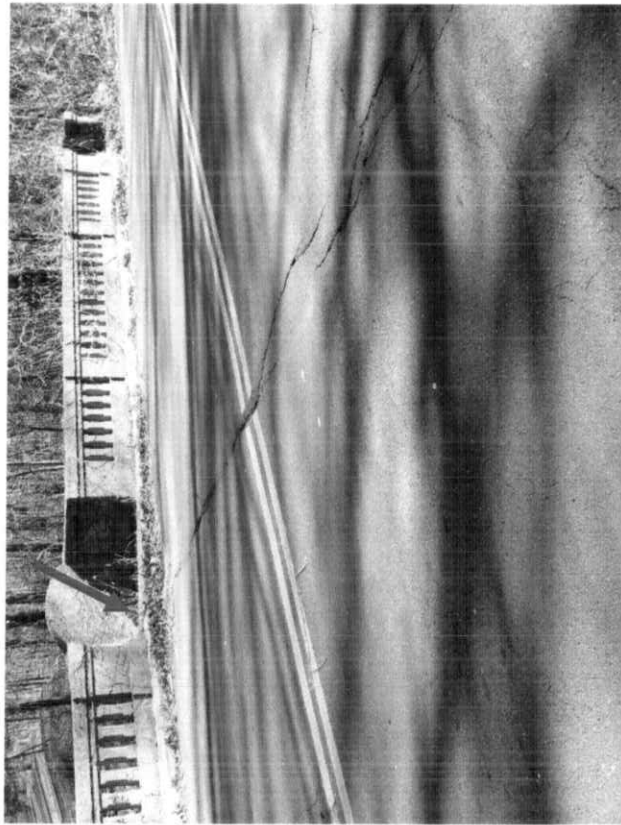
Description 2: Transverse crack in overlay at south deck / frame edge. Crack aligns with joint in curb / railbase.

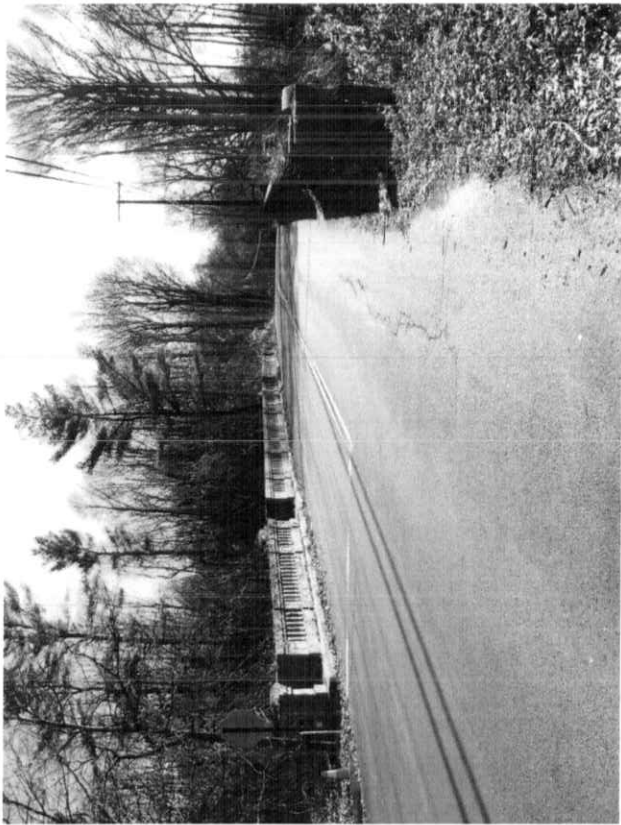
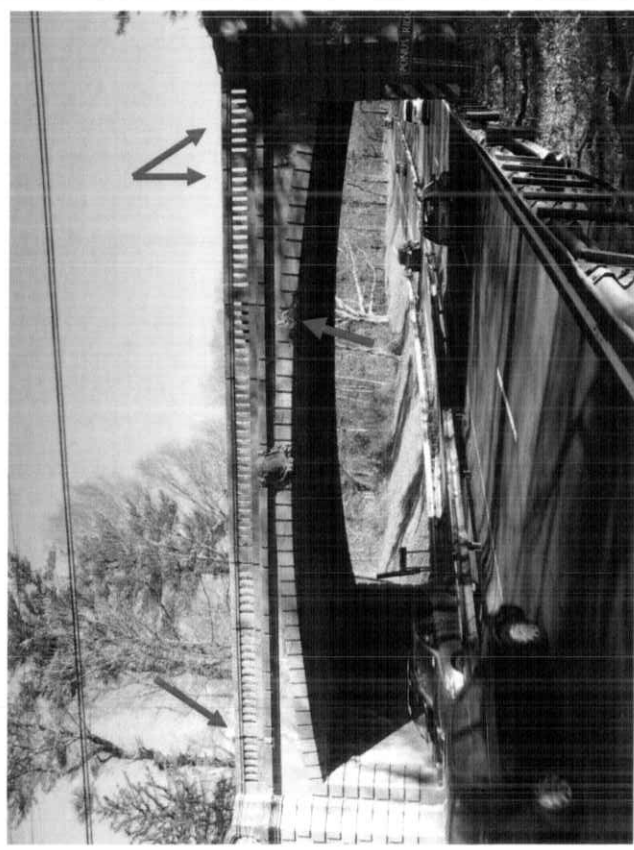
<p>Description 5: Looking across bridge from north approach.</p>	<p>Description 6: West elevation showing cracking of fascia at NW and SW corners and severe scale over left lane of NB Rte 15.</p>

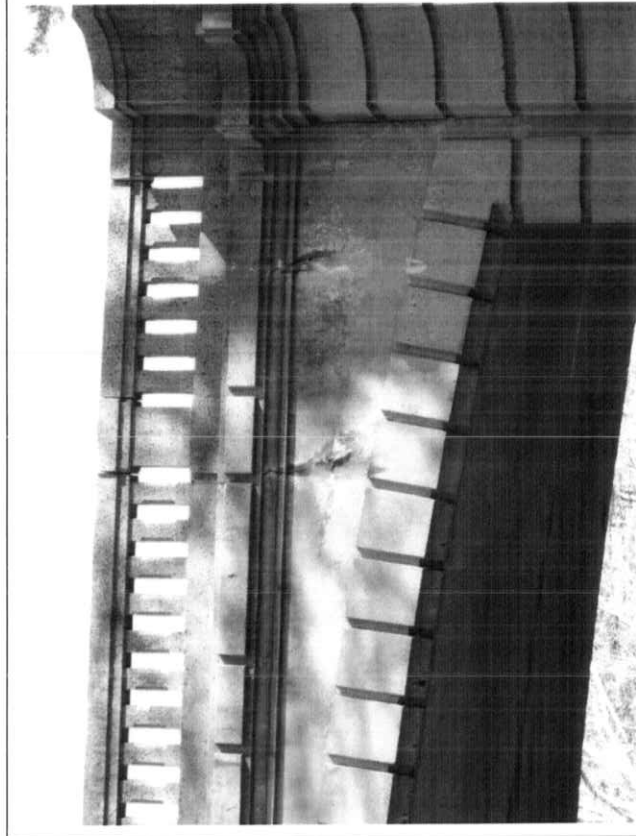
Description 9: Close up of cracking of fascia at the SW corner (cracks open 0.40" to 1/16").

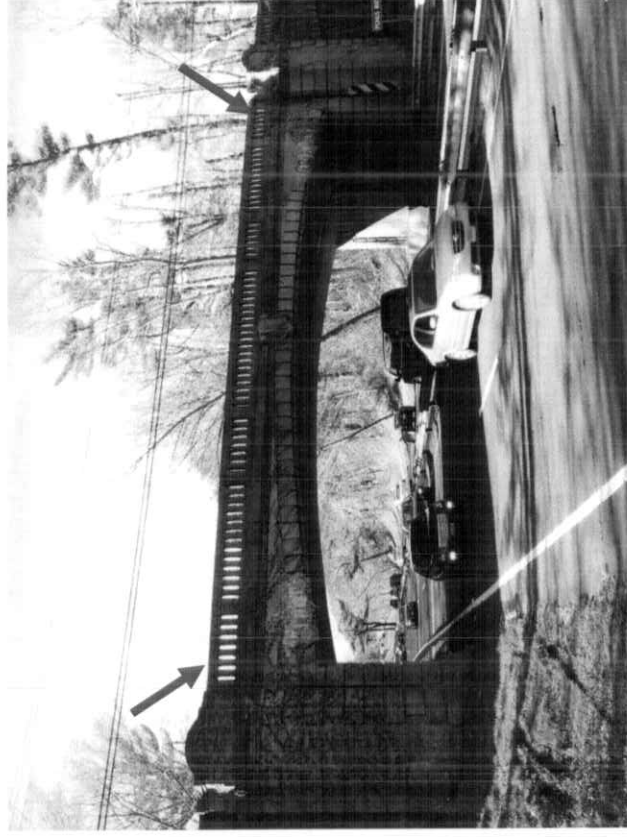
Description 10: East elevation showing large areas of severe scale on fascia at NE and SE corners.

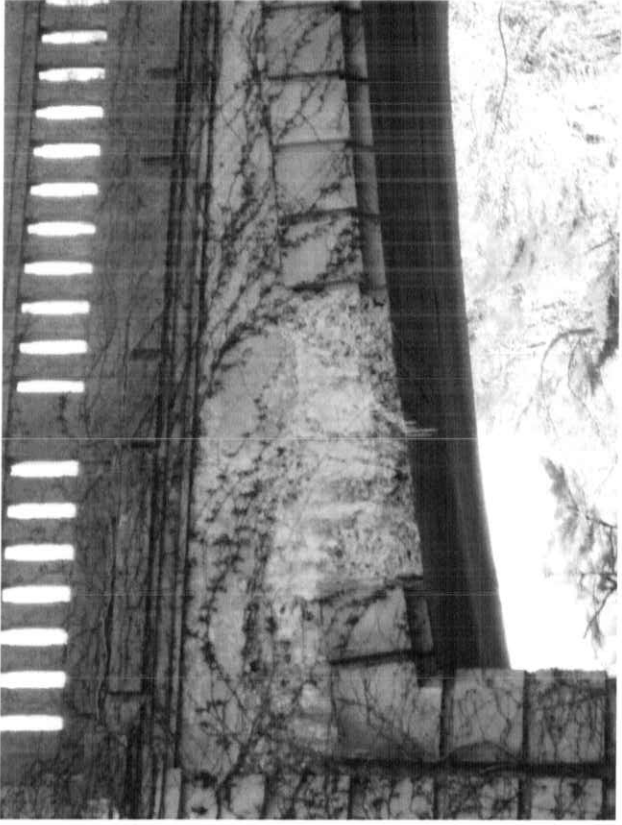
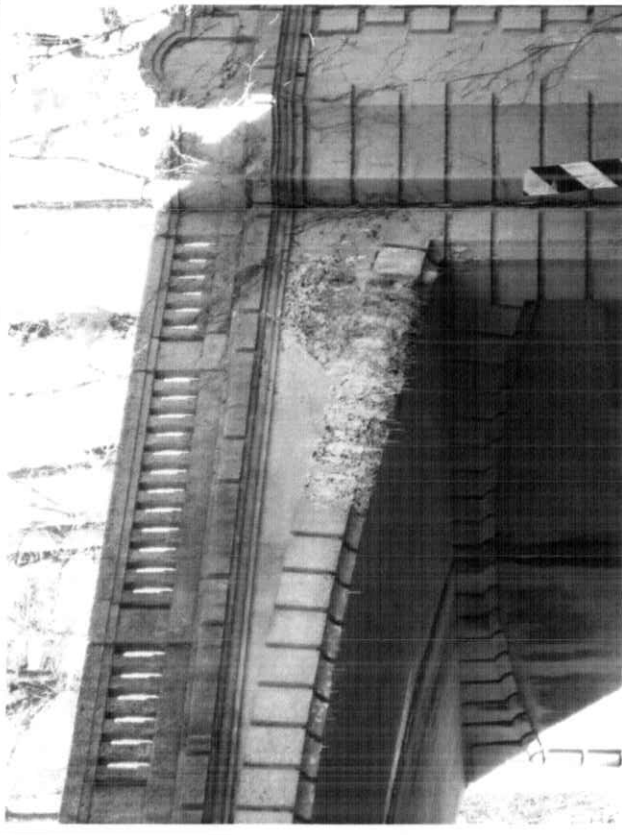
<p>Description 11: Close up of severe scale on fascia at SE corner. Total 19.5 SF x 4.5" deep.</p>	<p>Description 12: Close up of severe scale on fascia at NE corner. Total 39 SF x 8" deep.</p>

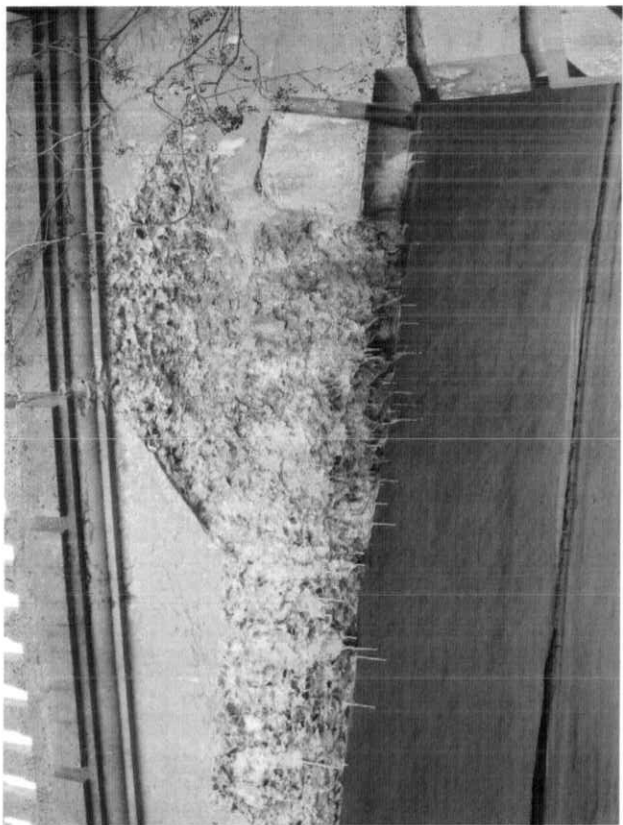
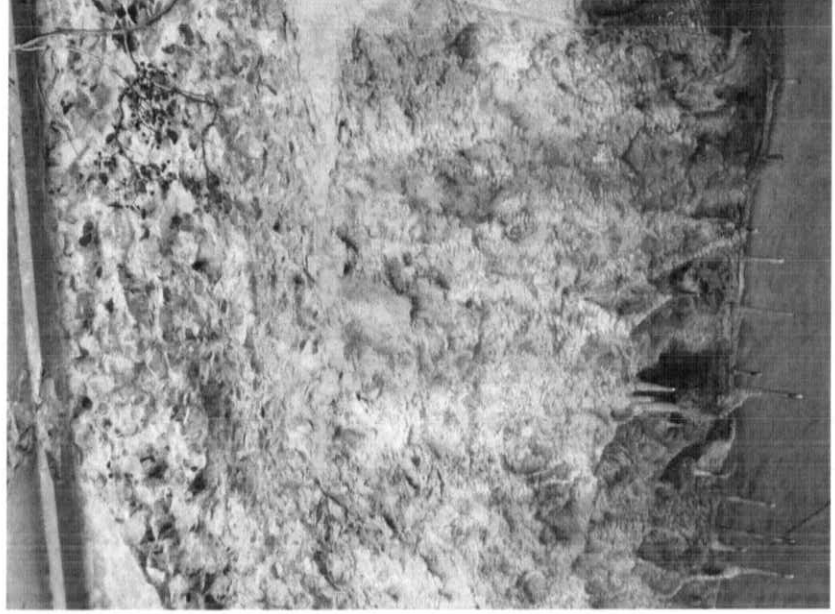
<p>Description 13: Close up of severe scale on fascia at NE corner. Total 39 SF x 8" deep.</p>	<p>Description 14: Close up of severe scale on fascia at NE corner. Note active leakage and very heavy efflorescence at area of deepest scale.</p>

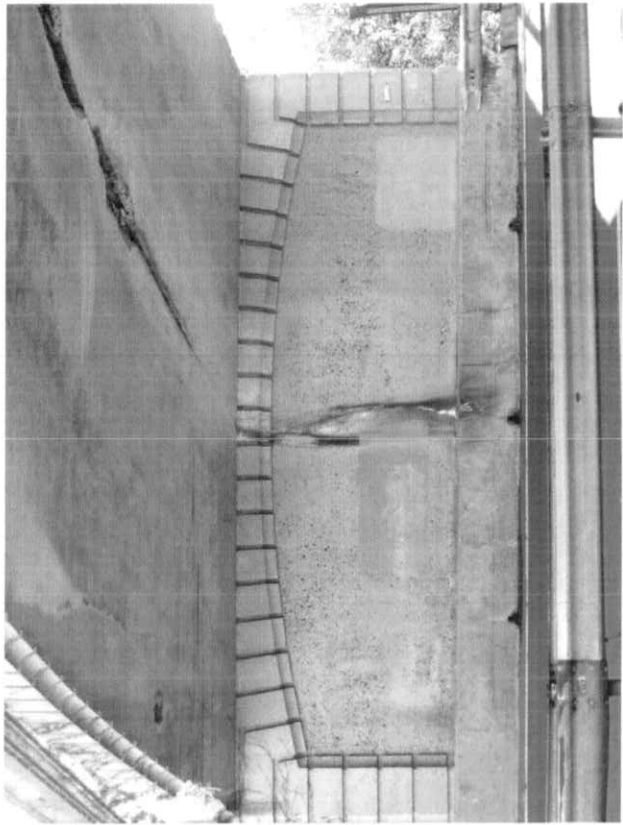
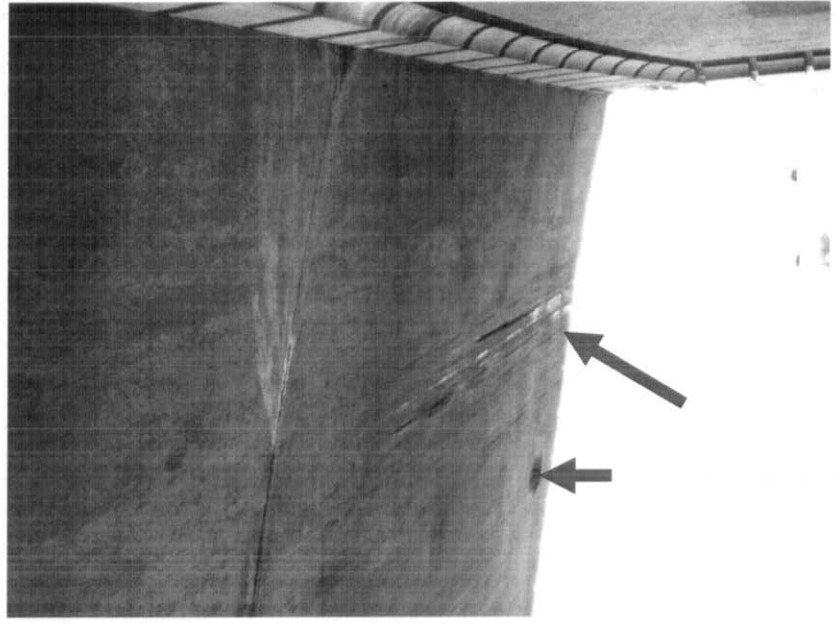
<p>Description 15: South frame leg showing vertical crack (0.20" open) with heavy efflorescence and south end of frame slab soffit with heavy spalling and exposed rebars along longitudinal construction joint.</p>	<p>Description 16: Southeast corner of frame intrados showing area of scrapes and isolated spall. Also note staining and efflorescence on either side of longitudinal construction joint.</p>
--	---	---	--

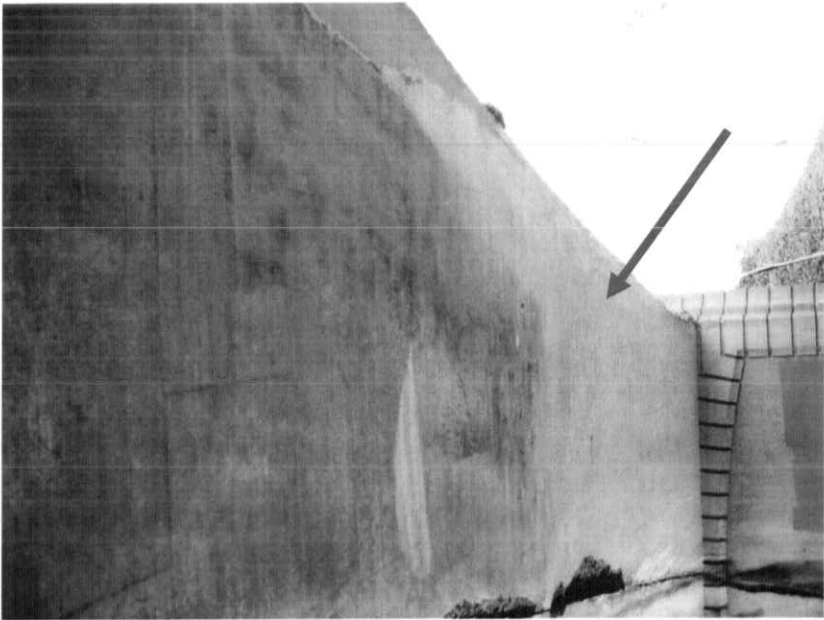
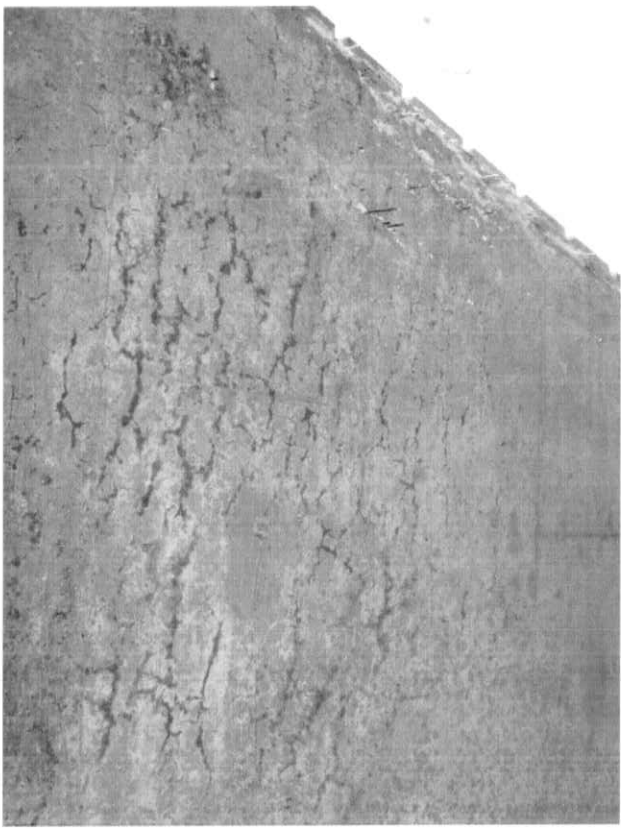
<p>Description 19: East side of intrados showing areas of mapcracking with dampness.</p>	<p>Description 20: Close up of mapcracking in Photo 20 (near tip of arrow).</p>
--	---	---	--

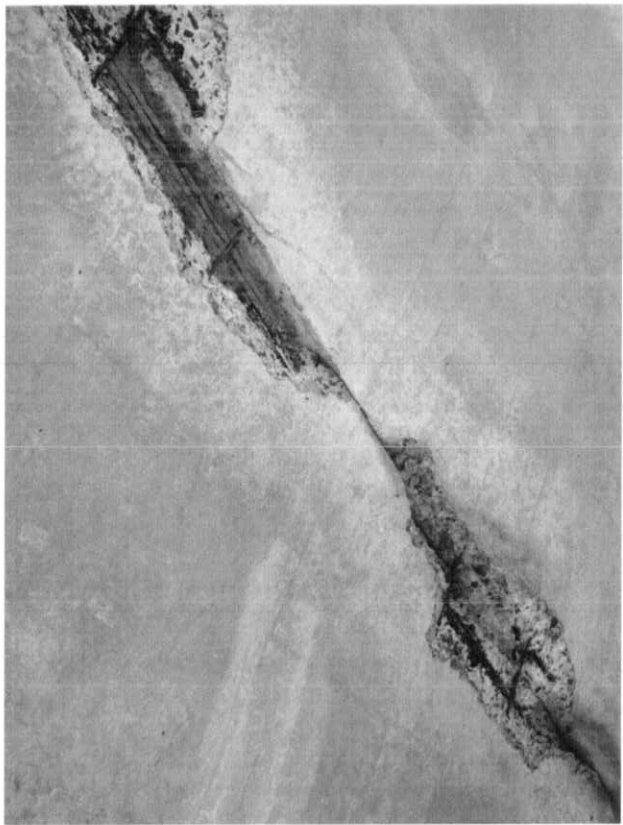
***The longitudinal joint exhibits leakage stains and 43 SF of spalling with exposed rebar for 30 LF in the mid-span area. Spalls range from 1 FT long x 1/2 FT wide and 1 rebar exposed up to 11 FT long x 1-1/2 FT wide and 4 rebar exposed. Rebar generally shows heavy laminar rust and significant section loss but due to limited access no details are available.

<p>Description 21: View of spalls with exposed rebar along longitudinal joint over NB lanes. Note some rebar previously coated with protective sealer.</p>

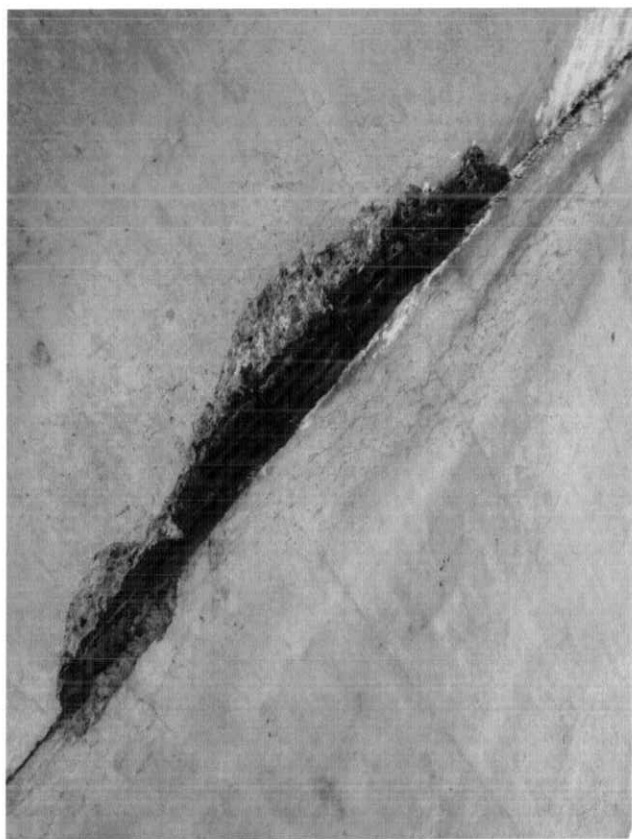
<p>Description 22: View of spalls with exposed rebar along longitudinal joint over SB lanes.</p>

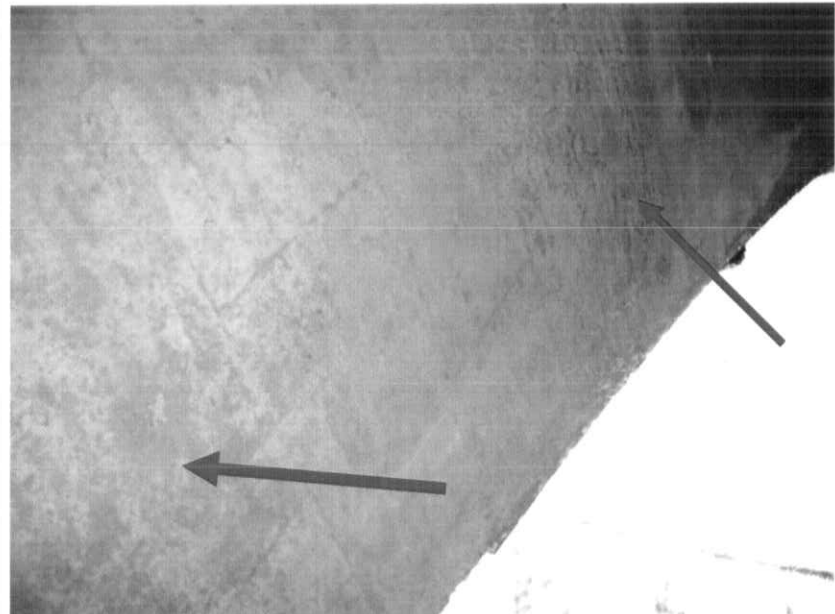
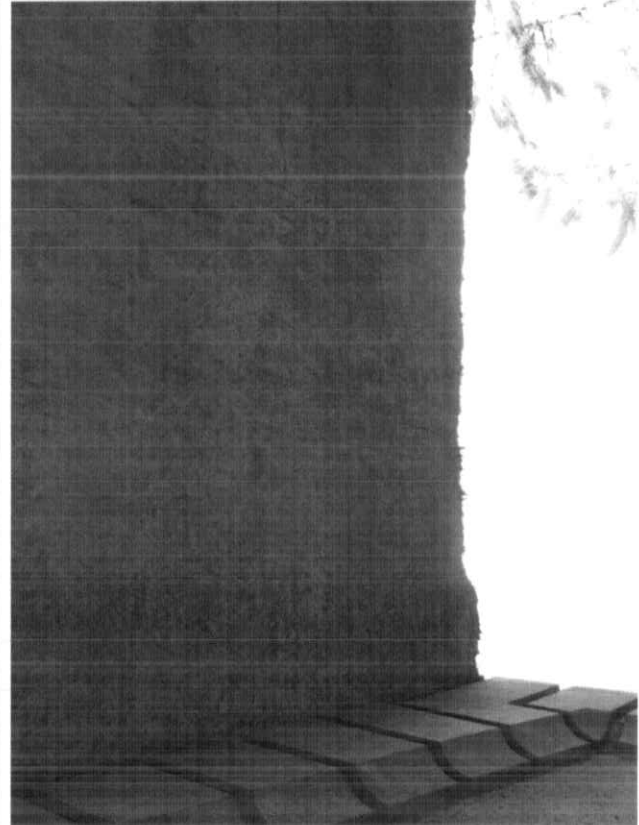
<p>Description 25: NE corner of intrados showing area of discoloration stains and latent mapcracks near north leg and area of mapcracking with dampness near midspan.</p>	<p>Description 26: NE corner of intrados showing area of discoloration stains and latent mapcracks near north leg.</p>

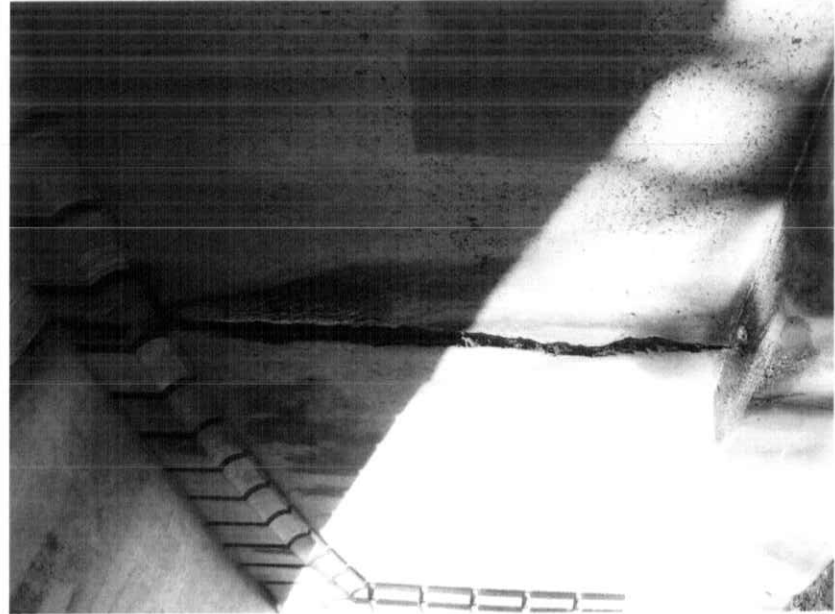
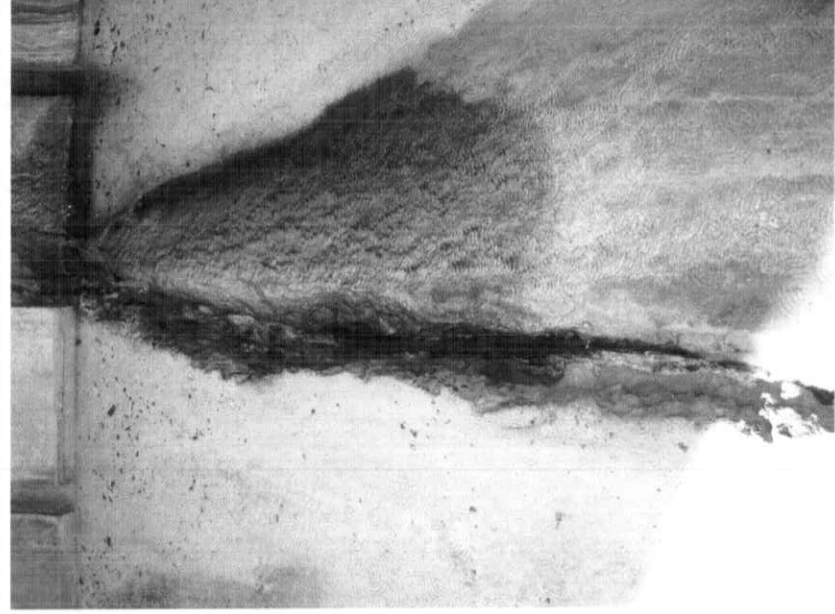
<p>Description 29: North leg of frame showing large crack (1/8" open) with associated scale up to 7" wide x 6" deep. Heavy active leakage at crack is running down over brush wall at leg base.</p>	<p>Description 30: North leg showing large crack (1/8" open) with associated scale up to 7" wide x 6" deep. Exposed vertical rebar shows severe rust with 38% section loss. Crack shows heavy active leakage and efflorescence.</p>

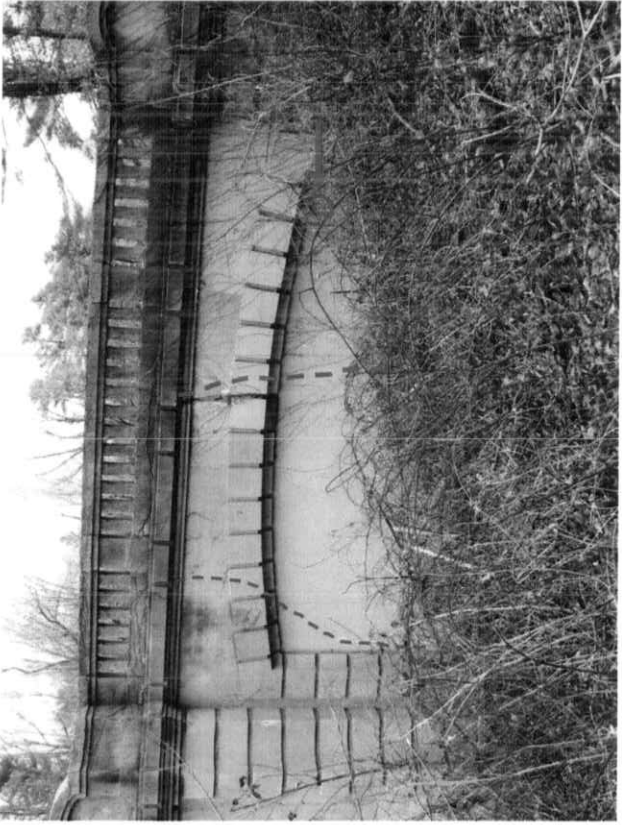
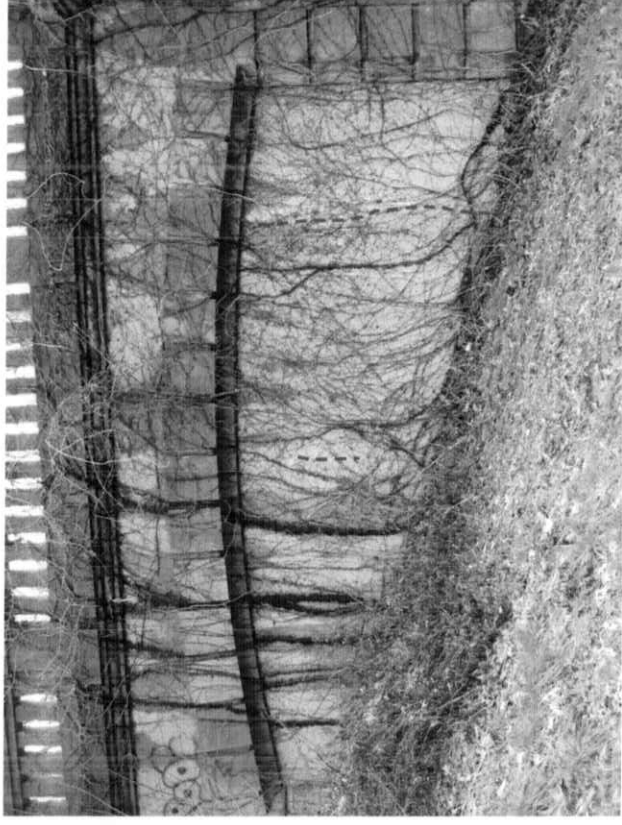
<p>Description 1: SW wing wall showing vertical cracks and spall with exposed rebar.</p>	<p>Description 3: SE wing wall showing an 8 FT and a 30 IN vertical hairline cracks.</p>

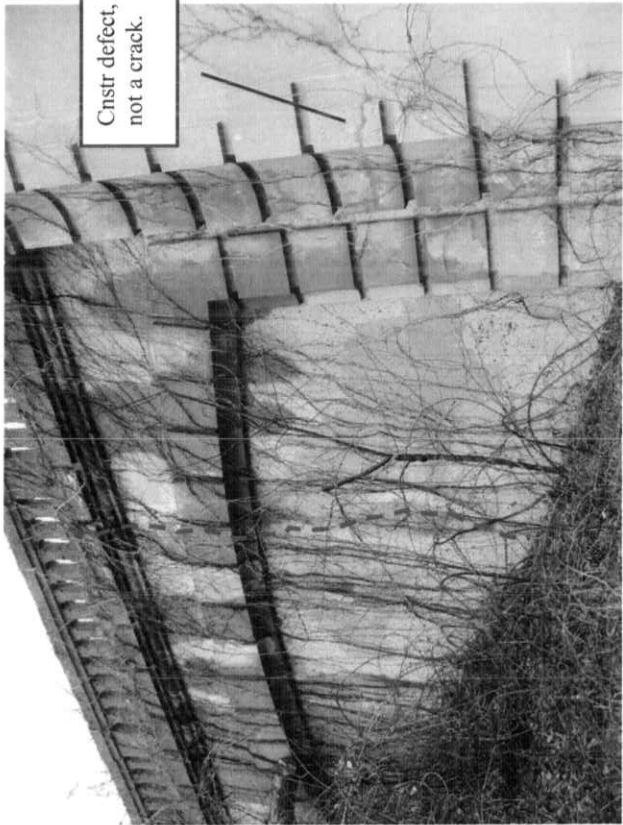
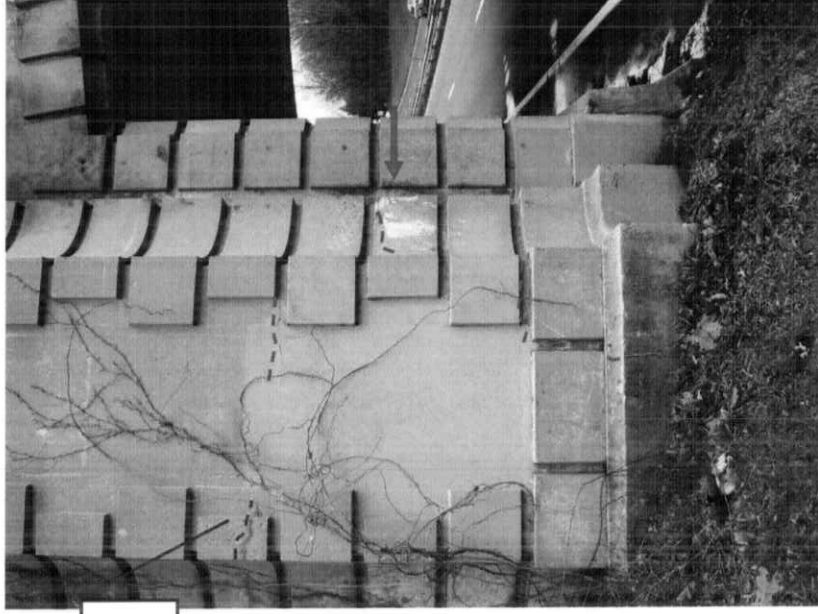
<p>Description 4: NW wing wall showing full height vertical crack open 1/32 IN.</p>	<p>Description 9: NW corner pylon showing horizontal and vertical hairline cracks. Note hairline crack with heavy efflorescence and adjacent spall at right side of photo. Also note construction defect (not a crack) at left side of photo.</p>

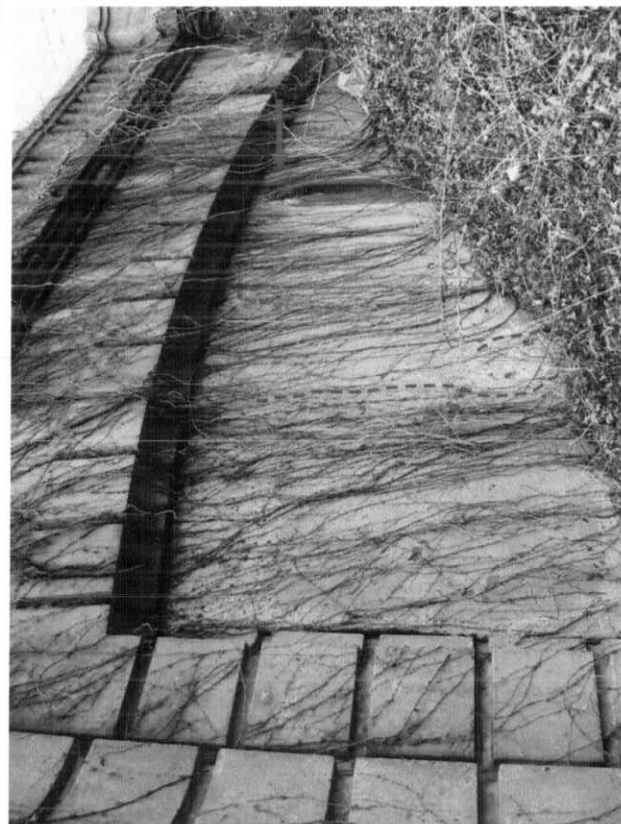
Description 10: NE wing wall showing vertical hairline cracks and large spall with efflorescence and active leakage.

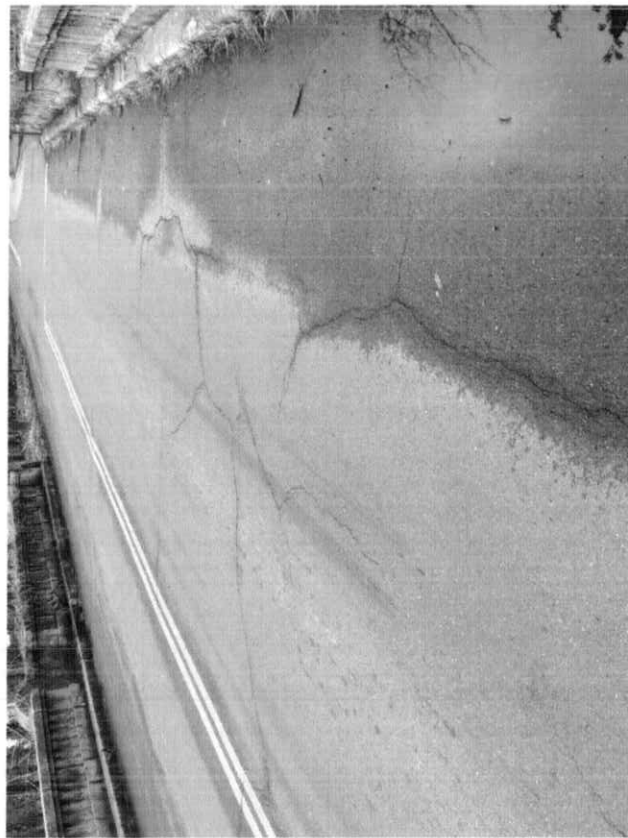
There are several longitudinal and transverse cracks and one random crack up to 25 FT long and 1/8 IN to 3/16 IN open. These cracks are primarily at the NE corner of the span.

Description 21: Heavy cracking of overlay at NE quadrant of bridge span. Cracks up to 3/16 IN open.
